Albany Neck & Bulb Transition Study

A Planning Tool for Site Enhancement

Existing Conditions Memo

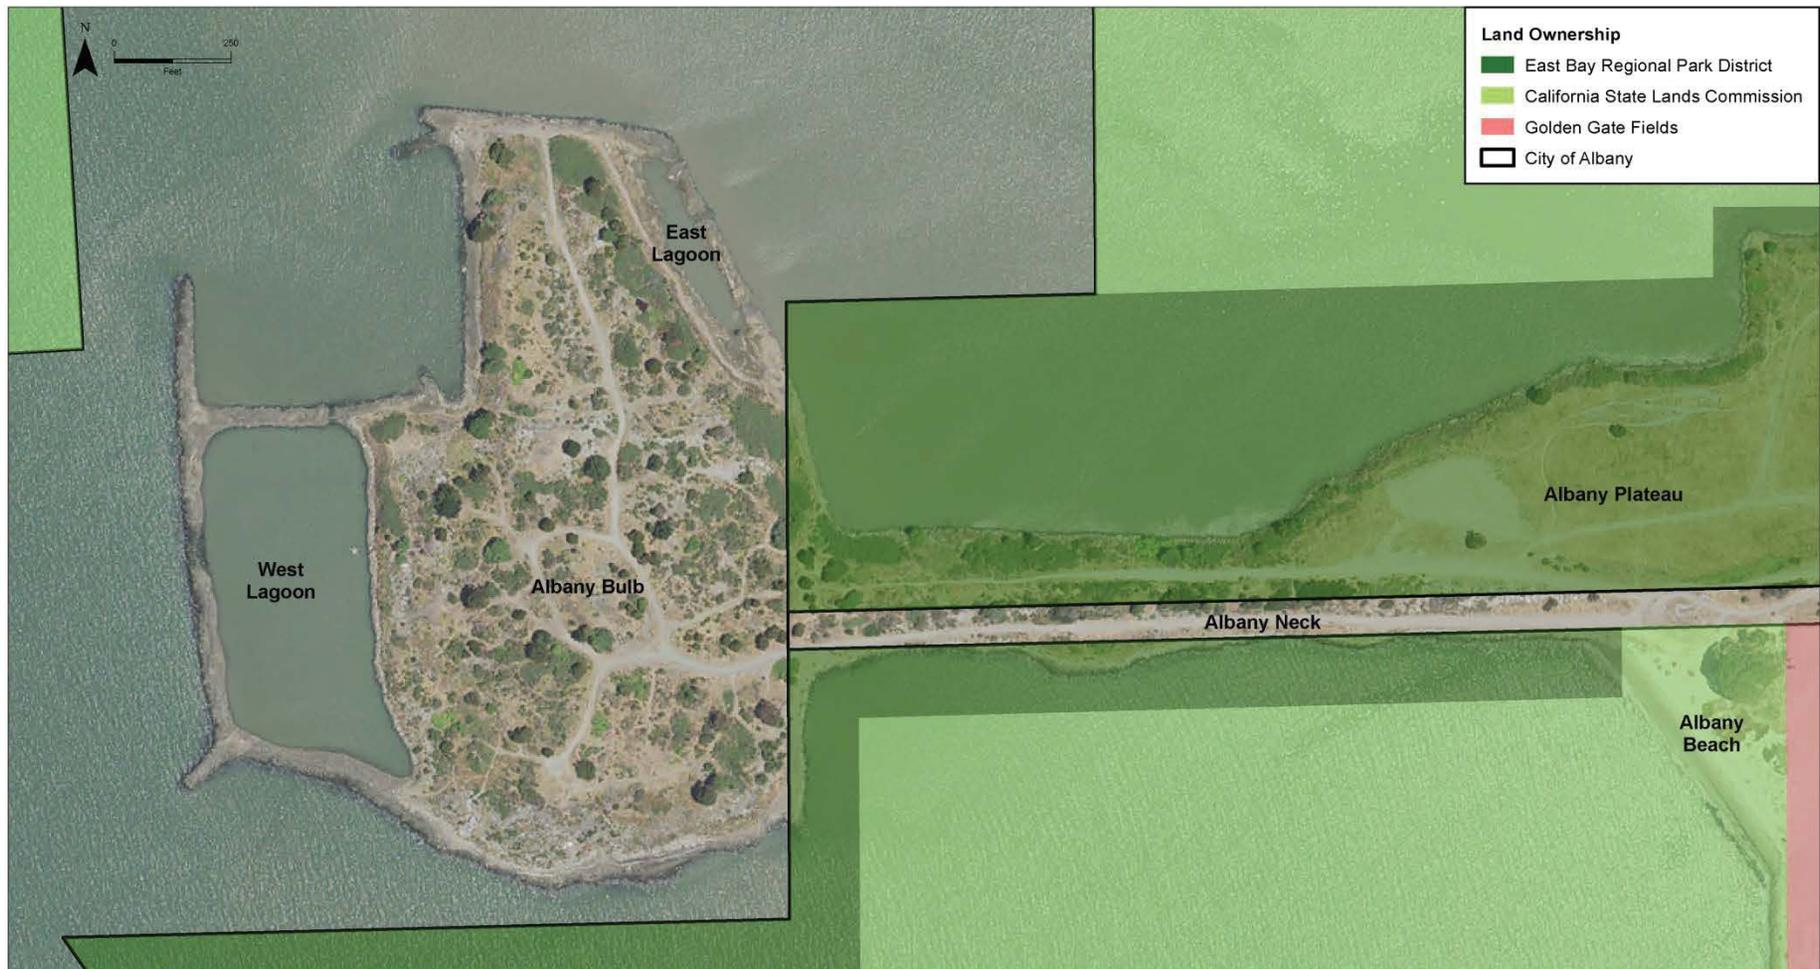
Figure 1.1a, Albany Neck & Bulb Land Ownership, Sources: NAIP 2014 (aerial photo), Alameda County 2015 (parcel data)

Approximately 88 acres of the waterfront are publicly owned by either the City of Albany, East Bay Regional Park District (EBRPD), or the State of California (and managed by EBRPD)(see Figure 1.1a). The Albany Plateau, Neck, and Bulb form the peninsula that extends westward from the Buchanan Street/I-80 interchange. The Plateau is a large, relatively level area at the east end of the peninsula and is currently owned by EBRPD. The Neck is a narrow isthmus that extends westward from the Plateau out to the Albany Bulb. The Bulb is a roughly oval-shaped area that comprises the western most portion of the peninsula. The project site is comprised of the City owned portions of the waterfront; the 31 acre Bulb and 7 acres of the right-of-way connecting Buchanan Street to the Bulb, known as the Neck.

Albany Beach has evolved naturally, generated by the interplay of tidal action and the contour of the landfill. The California State Lands Commission owns Albany Beach between the City's right-of-way to the north and the privately held Golden Gate Fields lands to the east (refer to Figure 1.1a). Albany Beach and the southern shoreline of the Neck are currently the focus of an extensive habitat and public access enhancement project.

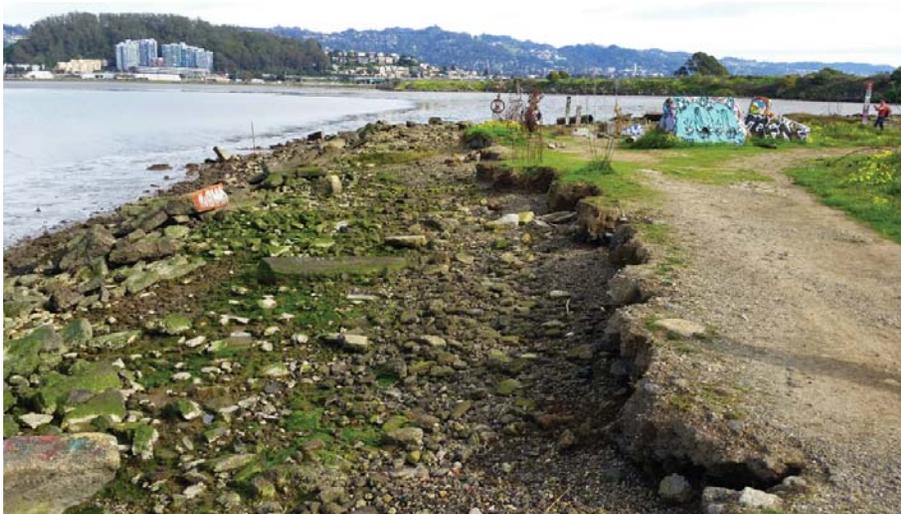
Existing site conditions at low tide

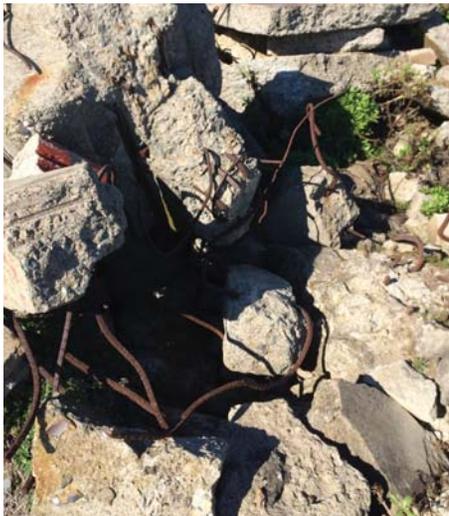
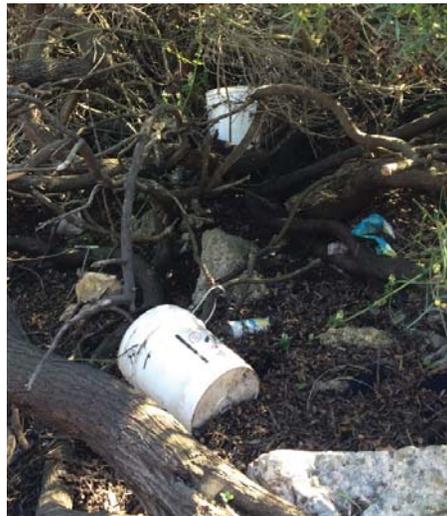
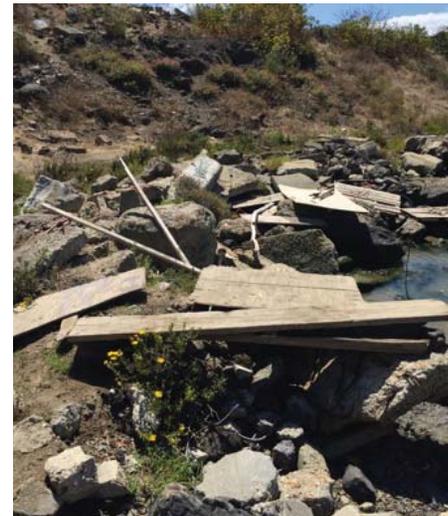
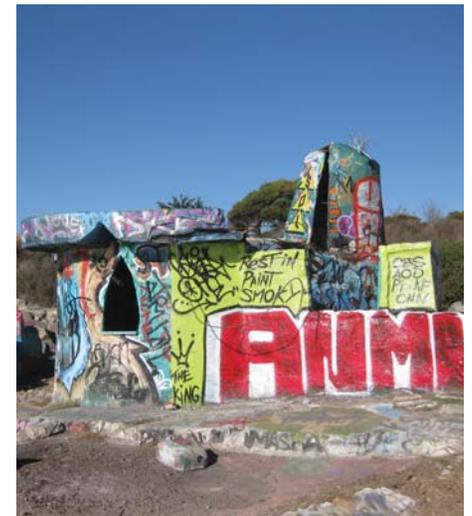
Construction debris and miscellaneous garbage pose risks to both site visitors and local wildlife

- **Remove hazardous concrete rubble in large areas subject to habitat enhancements**
Cost: \$2,800,000- \$3,200,000
- **Remove hazardous concrete rubble adjacent to primary trails and public use areas**
Cost: \$1,000,000- \$1,200,000
- **Remove protruding rebar near publicly accessible trails and public use areas**
Cost: \$85,000- \$100,000
- **Install signs alerting public of potential site hazards**
Cost: \$20,000- \$25,000

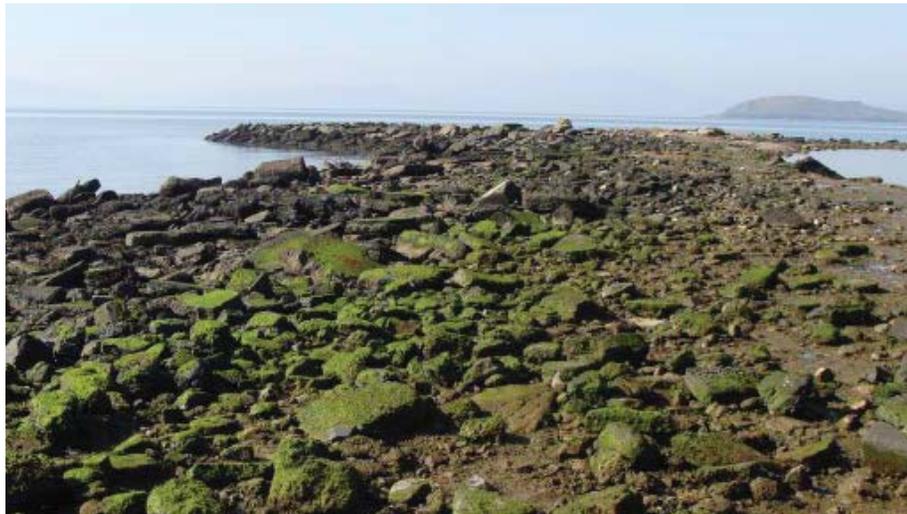
Existing conditions example: West Lagoon segment, looking west on the dike

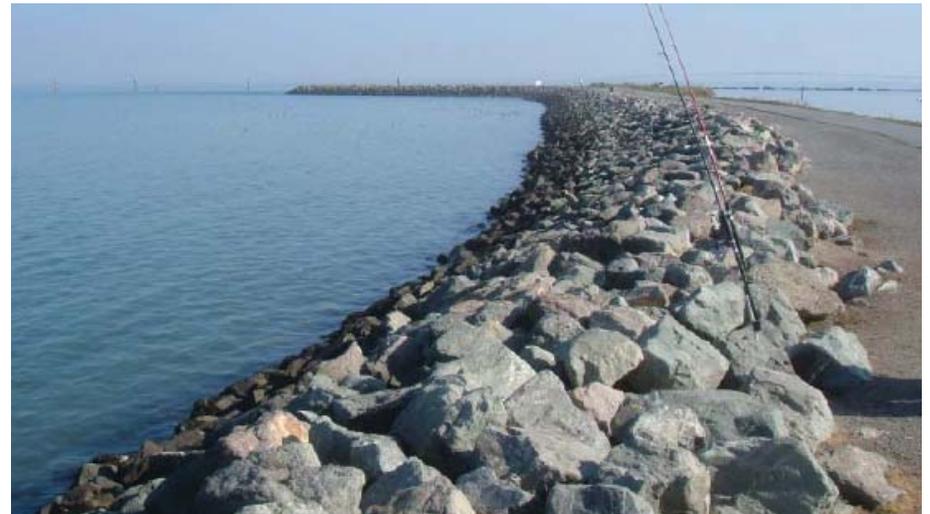
Engineered revetment example: Coyote Point, San Mateo, Photo: B. Battalio (ESA)

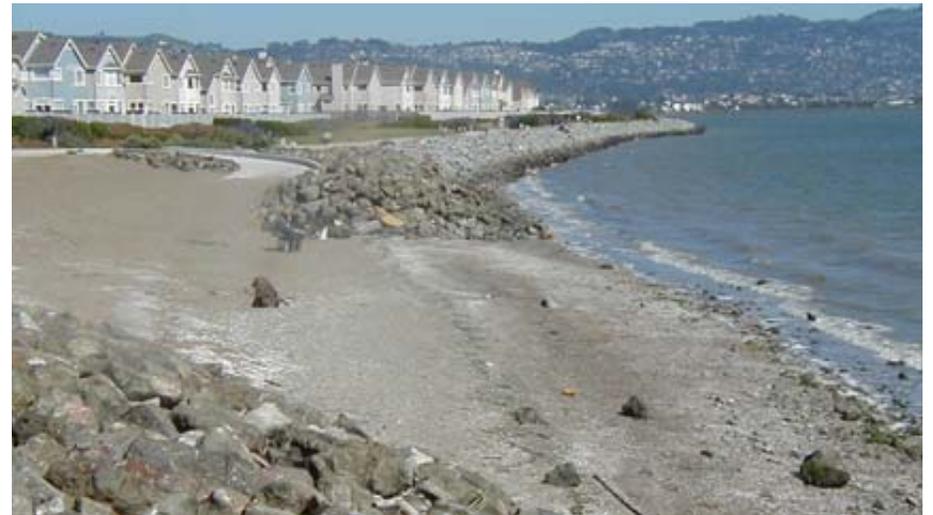
Engineered shore with coarse material example: Richmond, CA, Photo: B. Battalio (ESA)

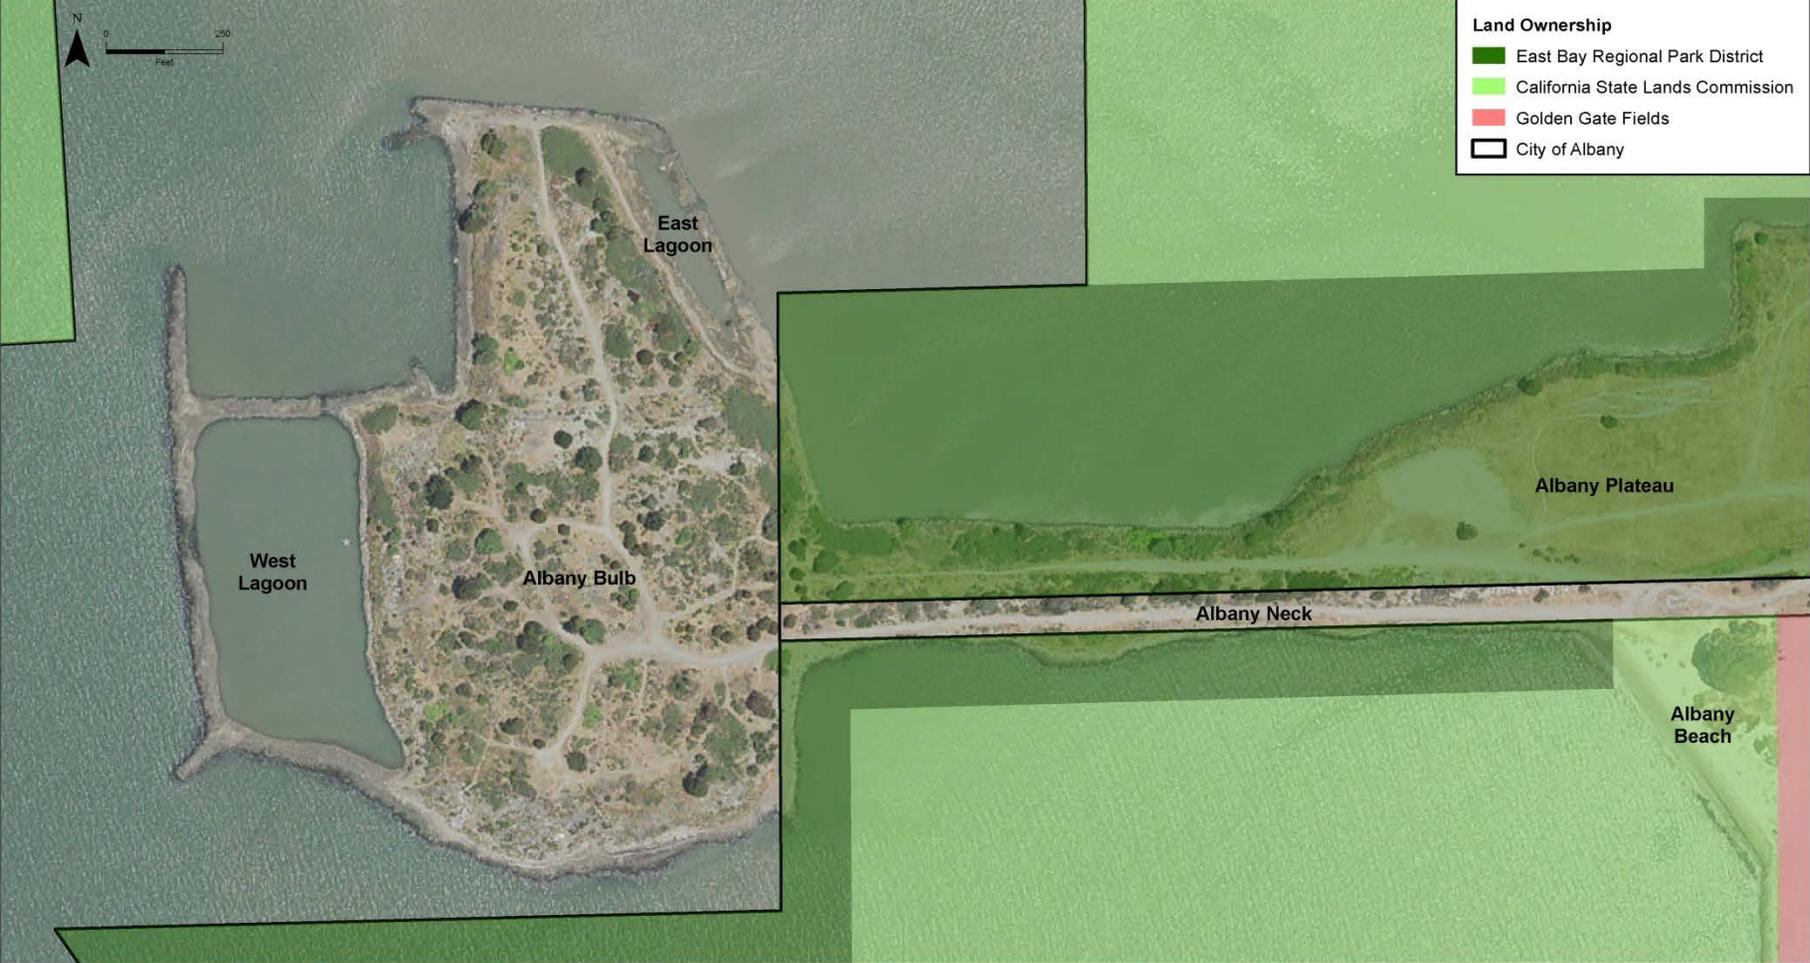
Figure 1.1: Land Ownership

The Albany Bulb, Neck, and Plateau comprise approximately 65 acres of upland open space along the Albany waterfront. Formed by the dumping of construction debris and related fill materials on Bay mudflats during the 1960's, -70's, and 80's, Bulb ownership is shared between the City of Albany and EBRPD (Figure 1.1). The City owns most of the Bulb (approximately 36 acres), as well as a narrow right-of-way through the Neck that connects the Bulb to Buchanan Street Extension (approximately 4 acres).¹ EBRPD owns the rest of the peninsula, including the Plateau and shoreline areas on the north and south sides of the Neck. The California State Lands Commission owns Albany Beach between the City's right-of-way to the north and the privately-held Golden Gate Fields lands to the east.

¹ The City's right of way extends through to the I-80/I-580 on-ramp; for purposes of acreage calculations in this memo, we are only considering the ROW through to the Golden Gate Fields properties (see Figure 1.1). The 36 acres described as "the Bulb proper" does not include outboard tidal mudflats or subtidal portions of San Francisco Bay within the City's parcel boundary.

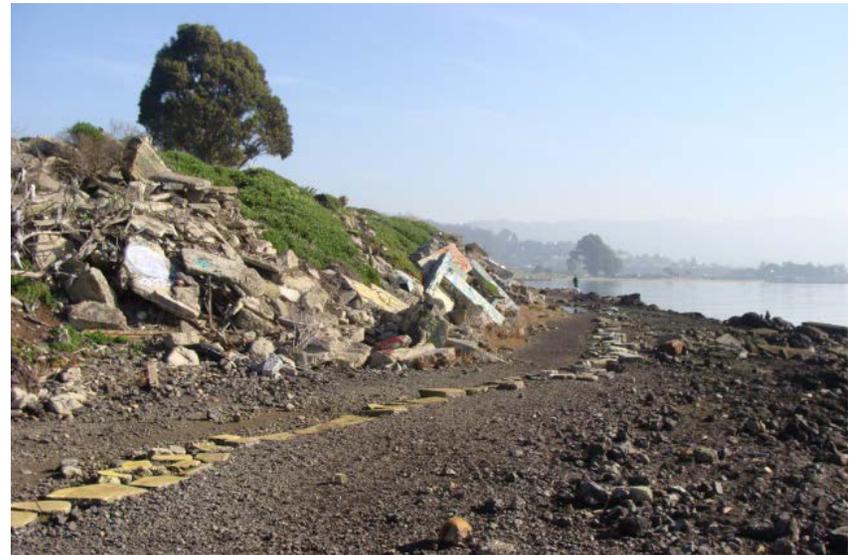
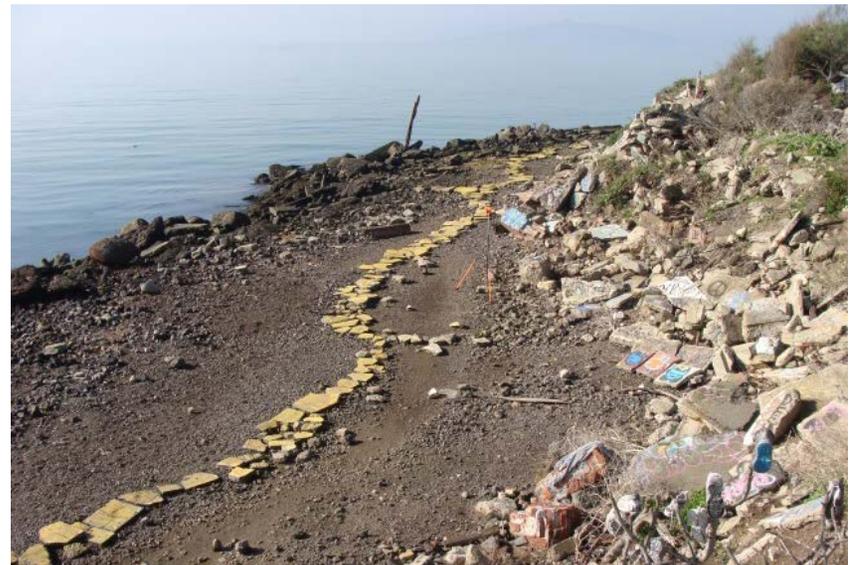
Segment A: South Shoreline. The South Shoreline segment stretches across approximately 800 feet of shore. The primary assets in this segment include rocky intertidal habitat and a rubble and slag dike that also functions as a shoreline access trail approximately 20 feet wide. The trail is backed by a steep landfill slope at the backshore that consists of concrete rubble and unconsolidated fill. Photos 2.1 and 2.2 show the South Shoreline segment with an extensive amount of concrete rubble and fill on the landfill slope and the trail that runs along the top of the rubble and slag dike. This segment is exposed to a long fetch across the Bay toward the southwest. The relatively low-lying surface of the shoreline access trail is periodically inundated by tides and flooded by wave runup and overtopping, as evidenced by puddles observed during the site visits. Section 'A' of Figure 2.3 shows a typical cross section of the South Shoreline segment.

Photos 2.1 & 2.2: South Shoreline segment looking south (top) and north (bottom).
Photos: L. White (ESA)

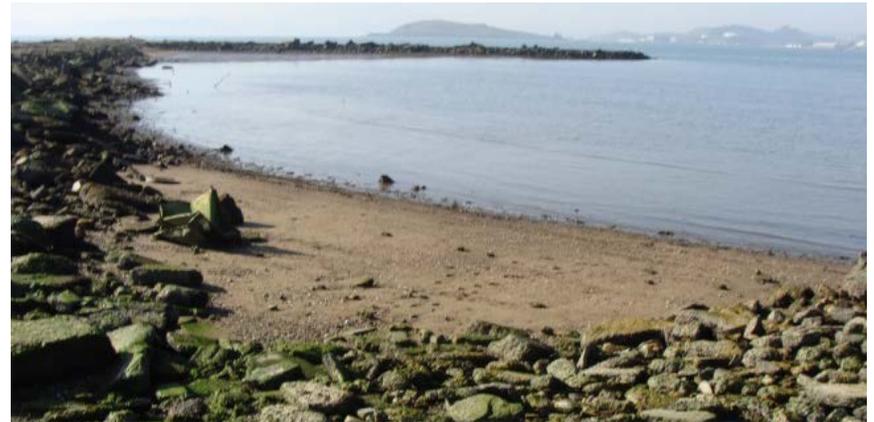
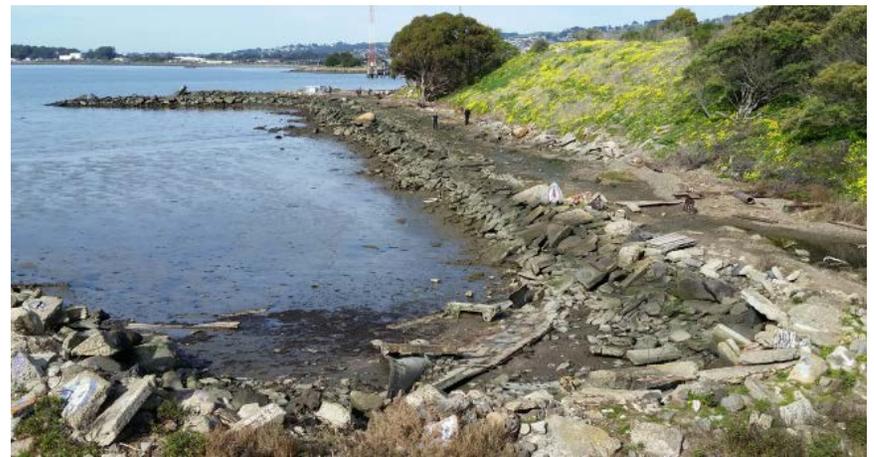
Segment C: Northwest Cove. The Northwest Cove segment is a small cove that is semi-protected from waves by rubble and slag dikes that act as breakwaters. Inside the cove, extensive mudflats have established, and two pocket beaches are located in the southwest and southeast corners. Along the east boundary of the cove, perched coarse beaches have established above and in back of extensive amounts of concrete rubble, which implies the presence of wave action at the bottom of the landfill slope. Although the shore is lined with rubble, an informal shoreline access trail is used by visitors, and is backed by a steep landfill slope primarily composed of unconsolidated fill with rubble. Section 'C' of Figure 2.4 shows a typical cross section of the Northwest Cove segment.

Photos 2.5 & 2.6: Northwest Cove segment; two small pocket beaches (top) and mudflat with rubble-lined shore (bottom). Photos: L. White (ESA) & G. Young (SCA)

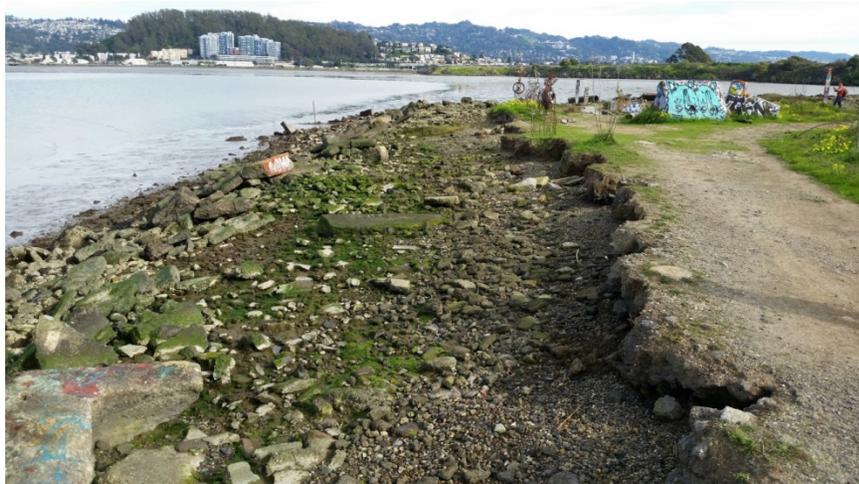
Segment D: North Shoreline. The North Shoreline segment runs west-east for approximately 300 feet of shore at the north end of the Albany Bulb. A public access trail extending from the interior of the Bulb to the shore terminates and “T’s” at the shore. The shore face is composed of concrete rubble and rock that extends from mudflats offshore to an erosion scarp of unconsolidated fill. Although this segment is relatively sheltered from waves, the water levels and incident waves have caused considerable erosion on the edge of the trail. Photo 2.7 shows the eroding edge of the trail and concrete rubble during a low tide. Note the art pieces in the back of the photo; several statues have been constructed from debris and other materials in this location. Section ‘D’ of Figure 2.4 shows a typical cross section of the North Shoreline segment.

Photo 2.7: North Shoreline segment; eroding fill transitioning to concrete rubble and mudflats during low tide. Photo: G. Young (SCA)

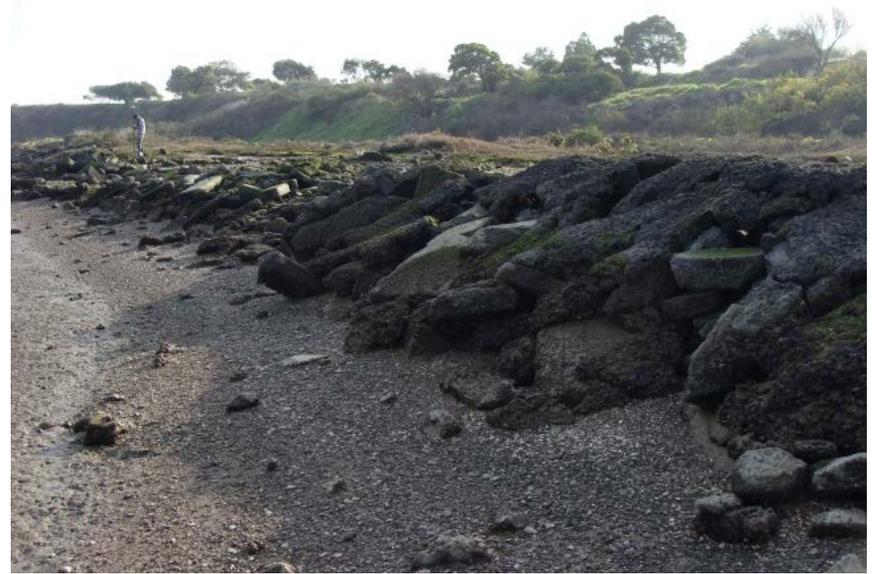
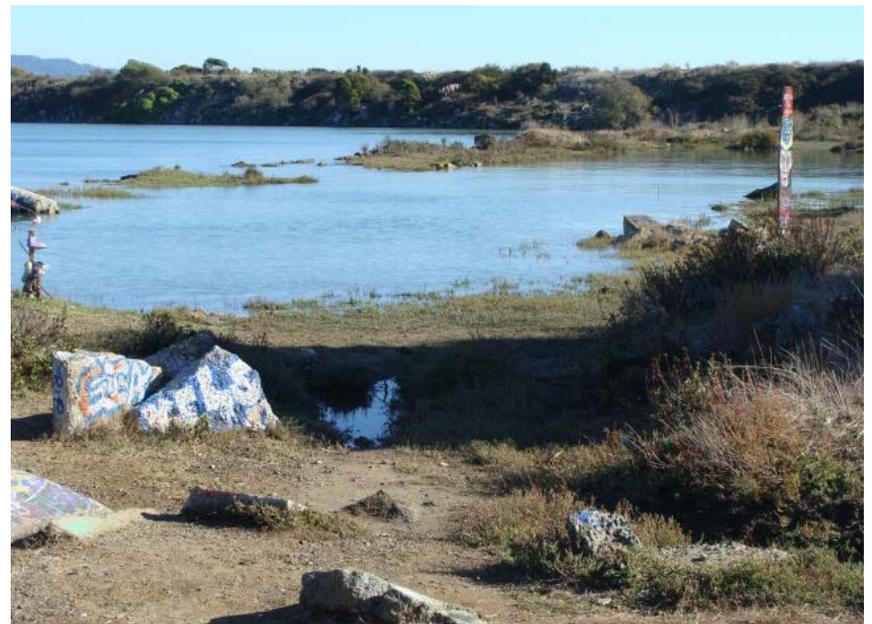
Segment E: East Lagoon Wetland. The East Lagoon Wetland segment is located in the northeast section of the Albany Bulb. This segment includes approximately 600 feet of shore and is the most sheltered segment on the Bulb. A perched lagoon with wetland habitats has formed behind a rubble and slag dike, and is inundated during high tides. A shoreline access trail is backed by a steep landfill slope consisting of unconsolidated fill and rubble. Extensive mudflats are located just offshore of this segment. Section ‘E’ of Figure 2.4 shows a typical cross section of the East Lagoon Wetland segment.

Photos 2.8 & 2.9: East Lagoon Wetland segment; the lagoon is perched by a rubble and slag dike (top) and inundated during high tide (right). Photos: L. White (ESA)

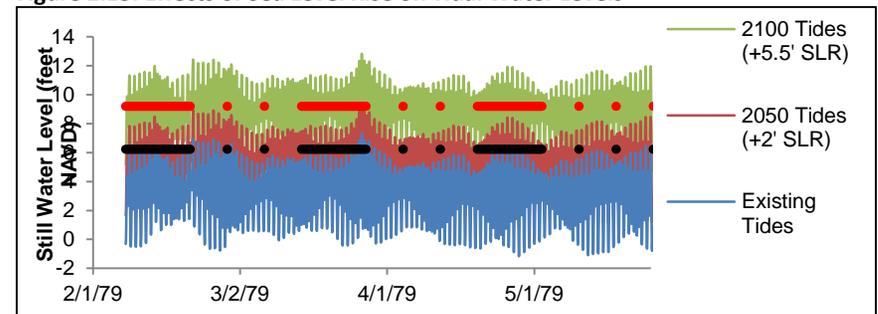
Figure 2.15: Effects of Sea Level Rise on Tidal Water Levels

Figure 2.15 presents time series of existing and future water levels near the Bulb relative to the existing MHHW and 100-year SWL. The figure shows that the percent of time that the water level exceeds a particular elevation occurs in discrete events typical of tidal systems. For example, for the existing conditions, the MHHW elevation is exceeded by one or two high tides per day during spring tide

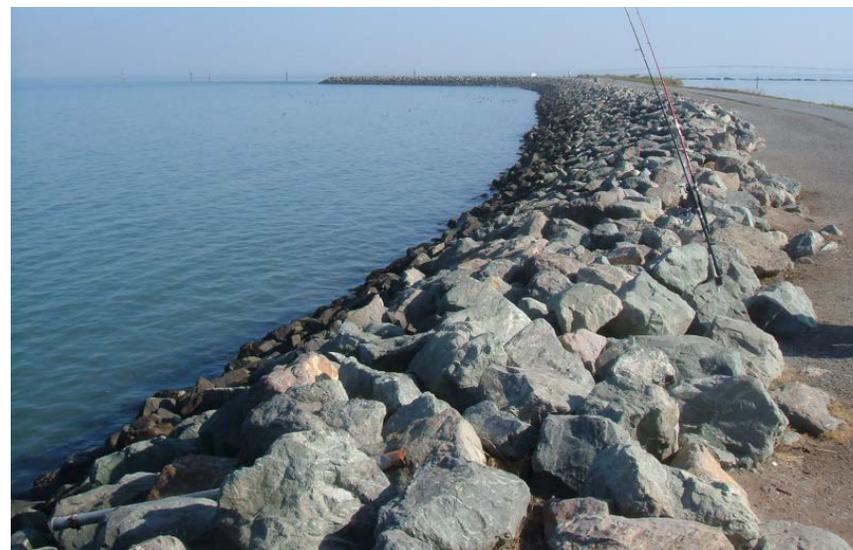
Photo 2.10: Example of an engineered revetment at Coyote Point, San Mateo.
Photo: B. Battalio (ESA)

Implementation of the engineered revetments along the different shore segments of the Bulb may be phased and configured differently. The South Shoreline segment will likely consist of the largest rock and with the highest elevation of armoring because of the existing exposure to significant waves and water levels. The West Lagoon segment, on the other hand, is currently protected from wave impacts by the existing slag and rubble dike, and so therefore construction of the engineered revetment may be able to be delayed until after other measures are taken to improve the site. These kinds of considerations should go into the conceptual project development.

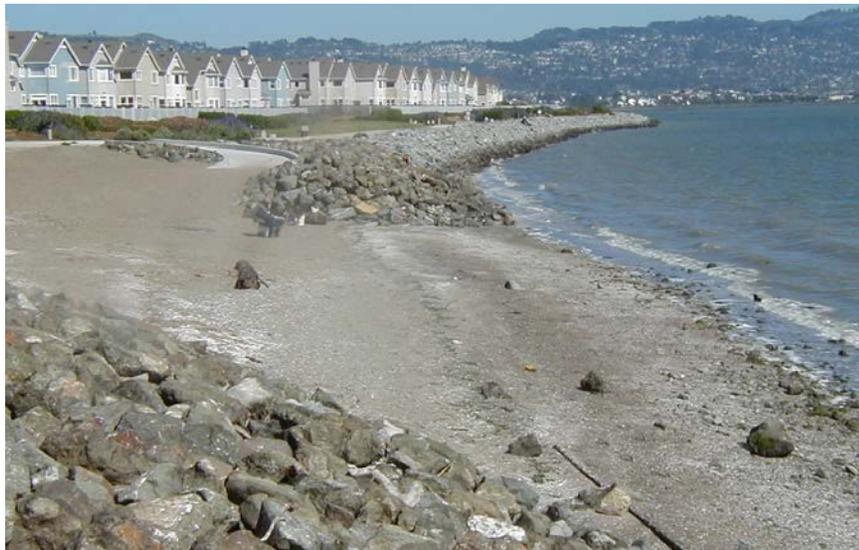
Because beaches are shaped by the waves and water levels, they will move with long-term changes in sea level as long as sufficient sediment is available in the system. A wide beach that experiences an increase in sea levels over time will adjust on its own accord by increasing in elevation. However, this will likely result in a narrowing of the beach as well, and therefore a sufficient amount of sand should be placed initially in anticipation that the beach will transgress.

Photo 2.11: Example of a constructed pocket beach along engineered shore in Richmond. Photo: B. Battalio (ESA)

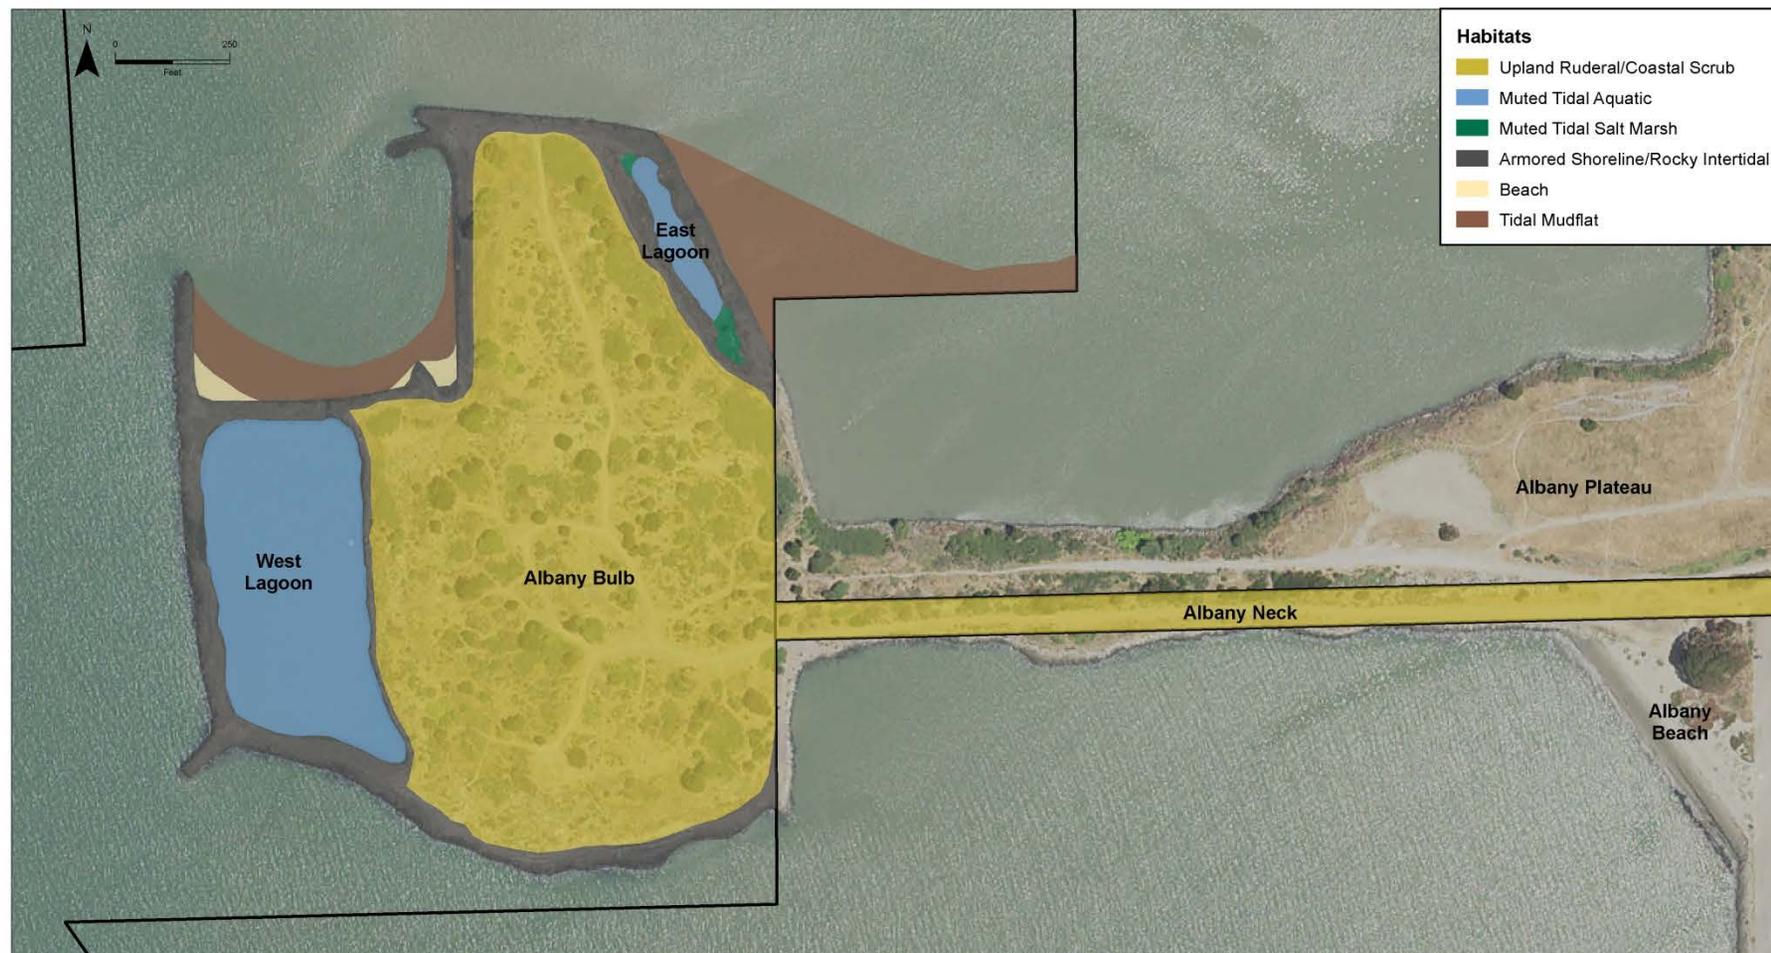
Figure 3.1: Habitat Areas

Habitats at the site can be broadly characterized into the following categories, displayed in Figure 3.1 and summarized in Table 3.2. Site topography (extracted from NOAA-OPC LiDAR)⁶ is displayed in Figure 3.2.

Upland ruderal/coastal scrub areas cover approximately 28 acres of the Bulb and Neck and range from roughly elevation +11 to + 51 ft NAVD. The ground surface in most areas is a mixture of fill soils and abundant landfill debris such as concrete and rebar. Many upland areas also contain garbage, assumed to be left from when the area supported a sizeable homeless encampment. Local artists have used landfill debris, garbage, and other refuse to create colorful art pieces dispersed throughout the area, particularly along the northern shoreline. ‘Desire’ trails crisscross the Bulb (Photo 3.1), and connect to more linear trails along the Neck that lead to and from Albany Beach, Golden Gate Fields, and Buchanan Street.

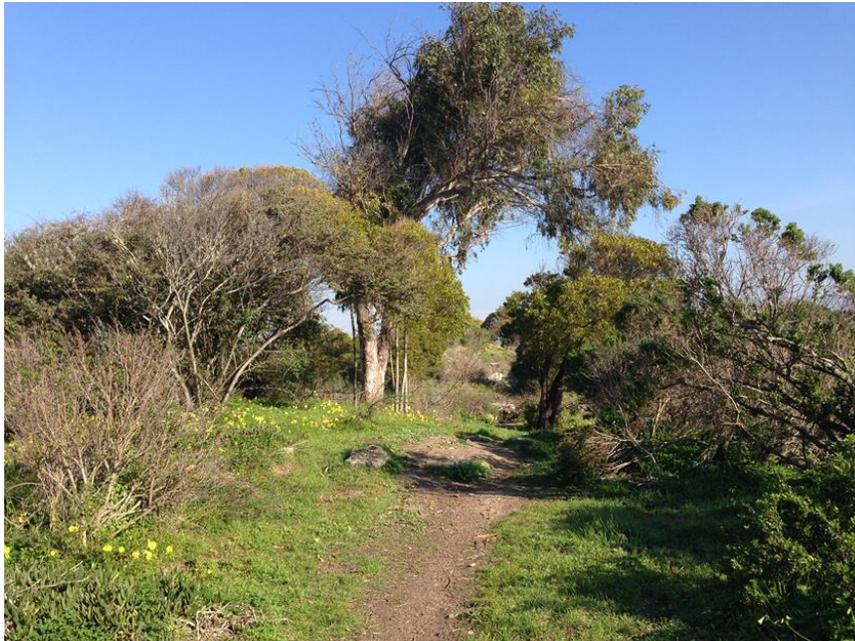
Photo 3.1: Upland ruderal/ coastal scrub habitats at the Albany Bulb. In this photo, taller eucalyptus trees dominate the canopy (background), while non-native acacias and native coyote brush make up the understory (foreground). Ground cover is provided by mostly non-native grasses and forbs, including the sourgrass (yellow flowers) in the photo's lower left corner. Photo: C. Toms (ESA).

Vegetation. Upon the cessation of landfilling operations at the Bulb in 1983, upland areas were quickly colonized by ruderal vegetation including a mix of non-native annual grasses and weeds. Over time, native and non-native coastal scrub species began to colonize the landfill's nooks and crannies. Most of the trees and shrubs at the Bulb (with the exception of French broom and coyote brush, see below) are naturalized in the wild from ornamental plantings, and are species known to favor disturbed areas. It's possible that some individuals were actively planted at the site. Over time, these communities have matured into a structurally complex matrix of ruderal/coastal scrub that covers most of the upland portions of the site.

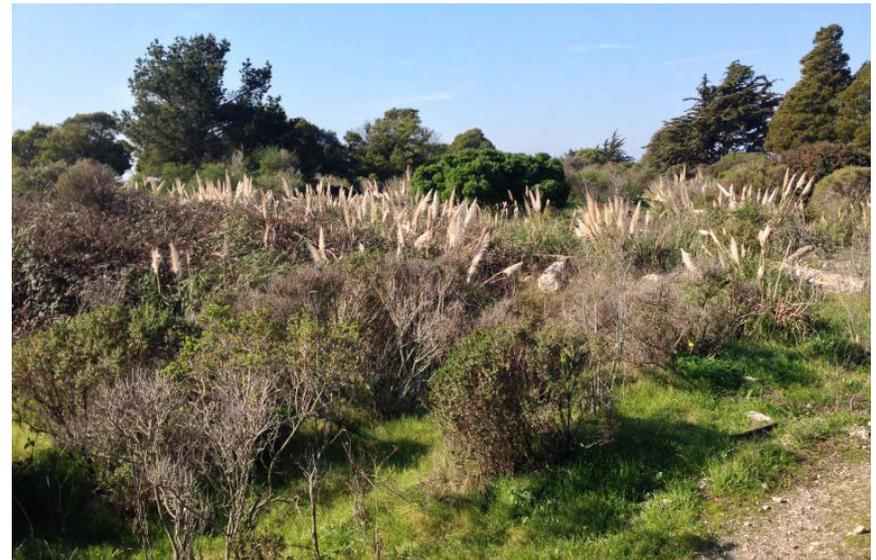
The shrub component of the canopy is dominated by shorter acacia trees, particularly the non-natives firethorn, cotoneaster, red valerian, French broom, and pampas grass, co-dominant with native coyote brush. The pampas grass stands can be locally dense, particularly in the northern portion of the site (Photo 3.2, Figure 3.3). Dense stands of non-native Himalayan blackberry are distributed throughout the site, particularly along its northeast shoreline. Small localized patches of native poison oak and coast live oak are also present, as well as native arroyo willow and blue elderberry in depressions between rubble piles. Ground cover in areas not covered by taller shrub/scrub vegetation is dominated by non-native annual grasses and forbs such as soft chess, ripgut brome, fennel, black mustard, Italian thistle, bull thistle, and sourgrass. Extensive patches of iceplant cover much of the Bulb's southern edge, and a large patch of English ivy is near the Bulb's center.

Photo 3.2: Pampas grass dominates the vegetation in discrete areas of the Bulb, such as this patch along the Bulb's northern side. Note the taller Monterey pine and Monterey cypress in the background, and coyote brush in the foreground. Photo: C. Toms (ESA).

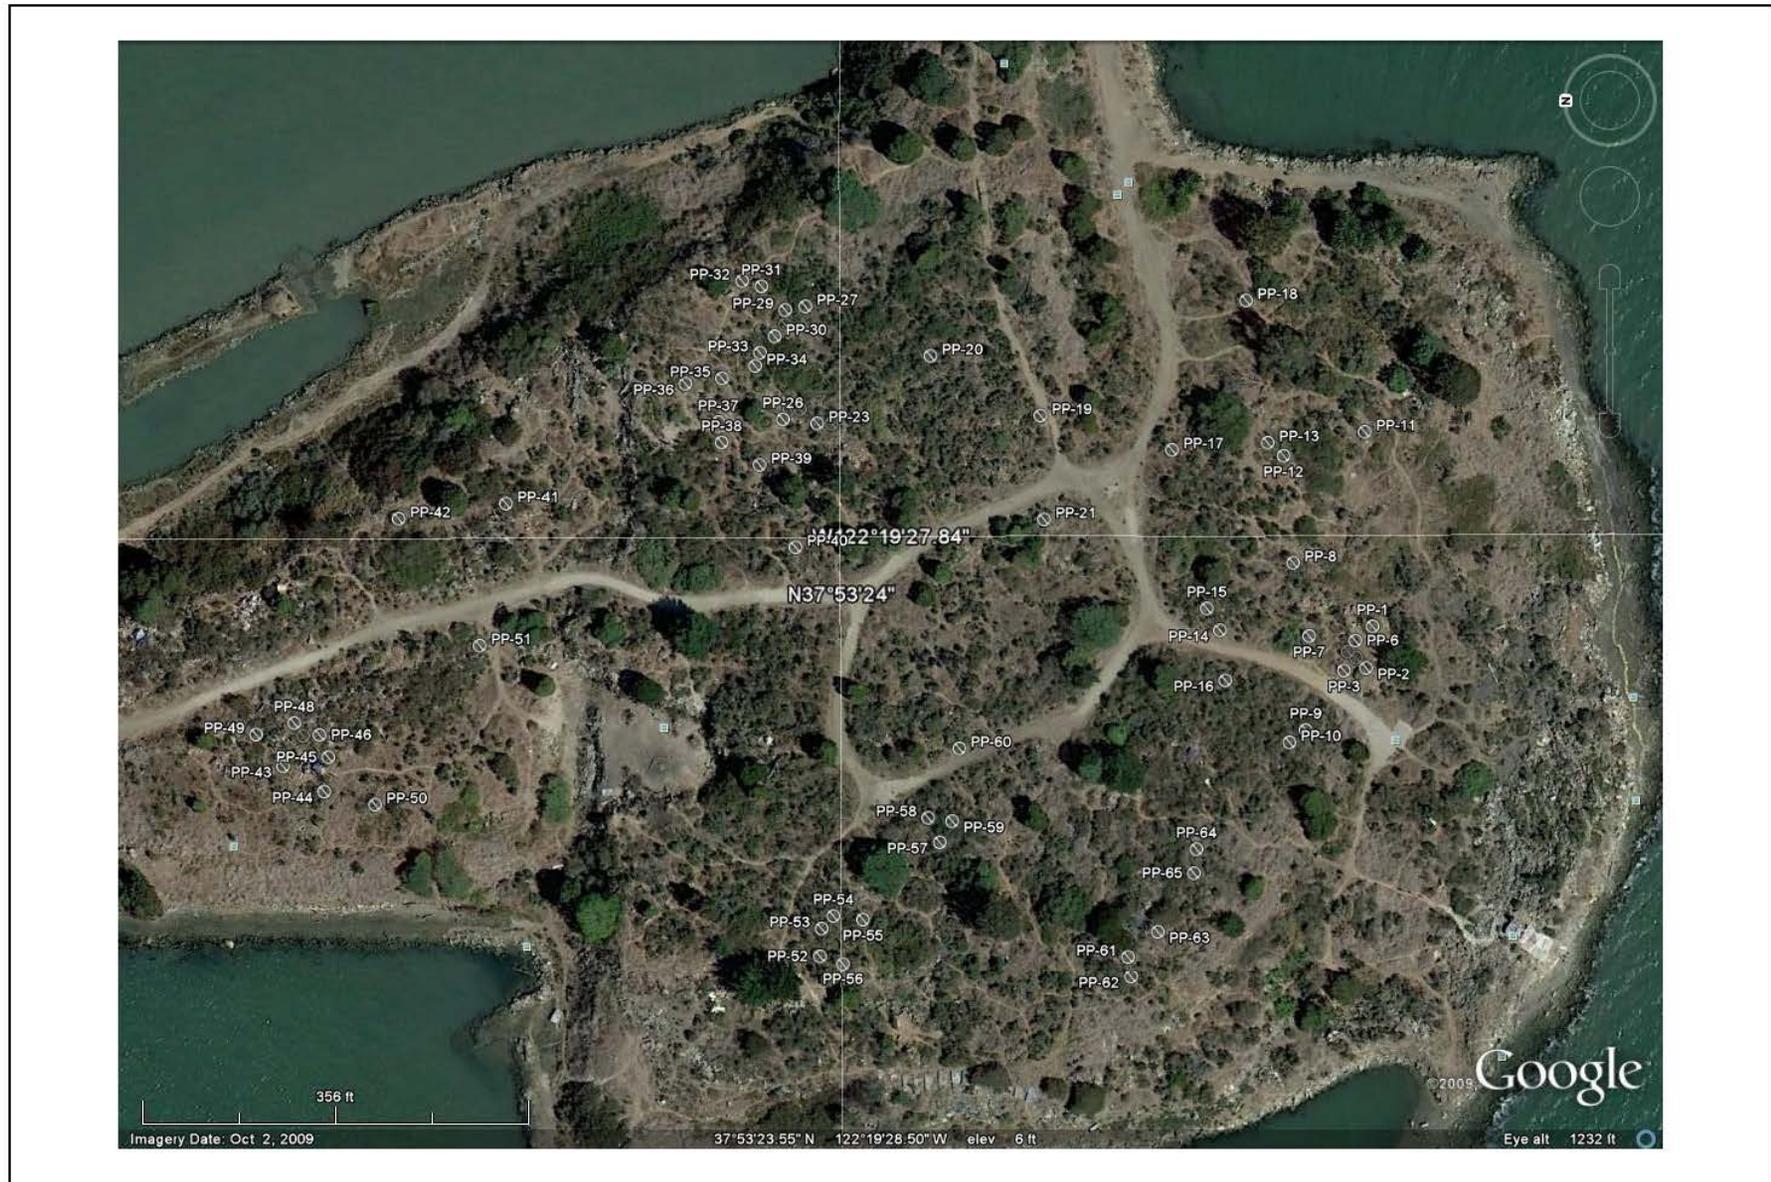
Figure 3.3: Approximate Pampas Grass Locations

Source: Peter Rauch, based on 2010 photo interpretation of Google Earth Oct 2009 imagery

Peter Rauch, retired, University of California, Berkeley (Fig. 3.3 pampas grass distribution, and plant data in Appendix E)

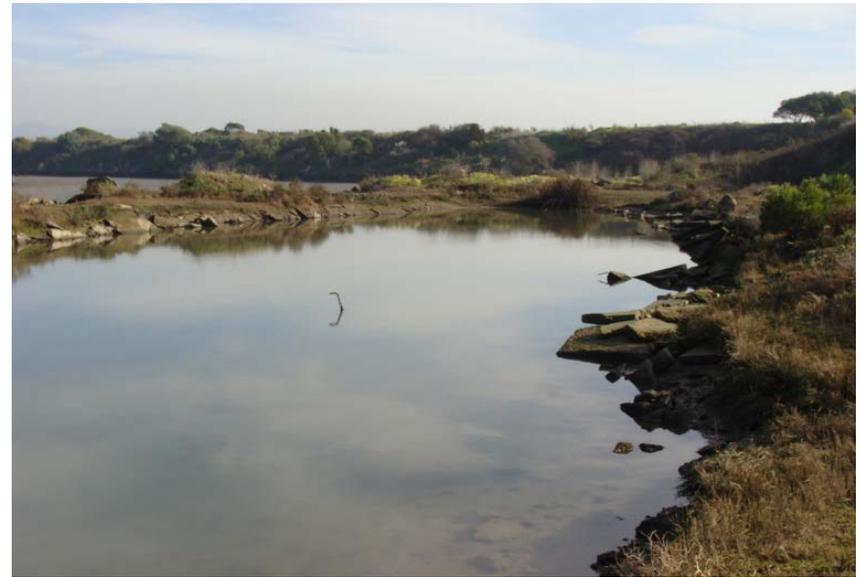
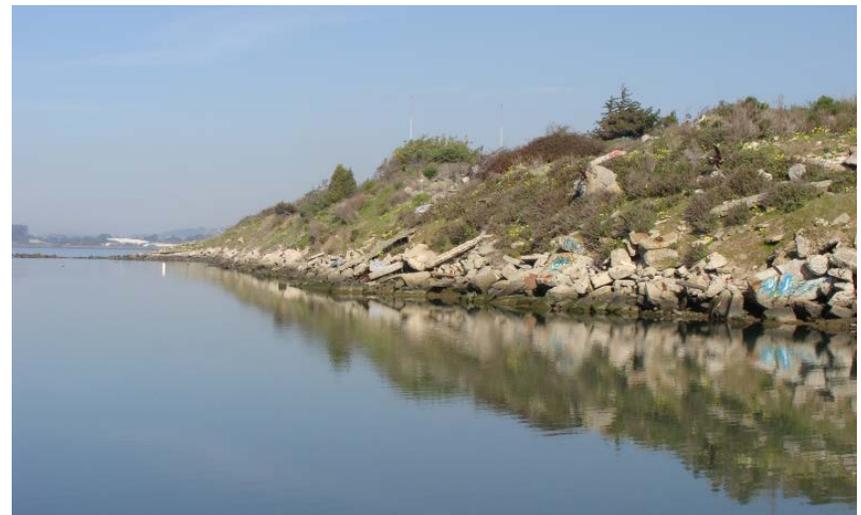
Photos 3.3 and 3.4. Muted tidal aquatic habitats in West Lagoon (top) and East Lagoon (bottom). Photos: C. Toms (ESA).

Muted tidal aquatic habitats are limited to West Lagoon (6 ac) and East Lagoon (0.5 ac). West Lagoon (Photo 3.3) is a broad, deep, rectangular embayment that was never filled and is largely devoid of any emergent wetland vegetation, whereas East Lagoon (Photo 3.4) is a much narrower, shallower system that is partially filled on both its north and south ends. The filled areas within East Lagoon support emergent wetland vegetation that is described below under Muted Tidal Salt Marsh. The landfill berms that surround the lagoons range from roughly +5 to +8 ft NAVD at West Lagoon, and from +3 to +8 ft NAVD at East Lagoon. Higher tides can overtop low points in the lagoons' perimeter berms, especially at East Lagoon, but the low points are not low enough to facilitate full drainage at low tide. The 2005 H.T. Harvey & Associates report mentions that the lagoons are "approximately 6 ft deep", but it is not clear at which tide stage this depth was measured.

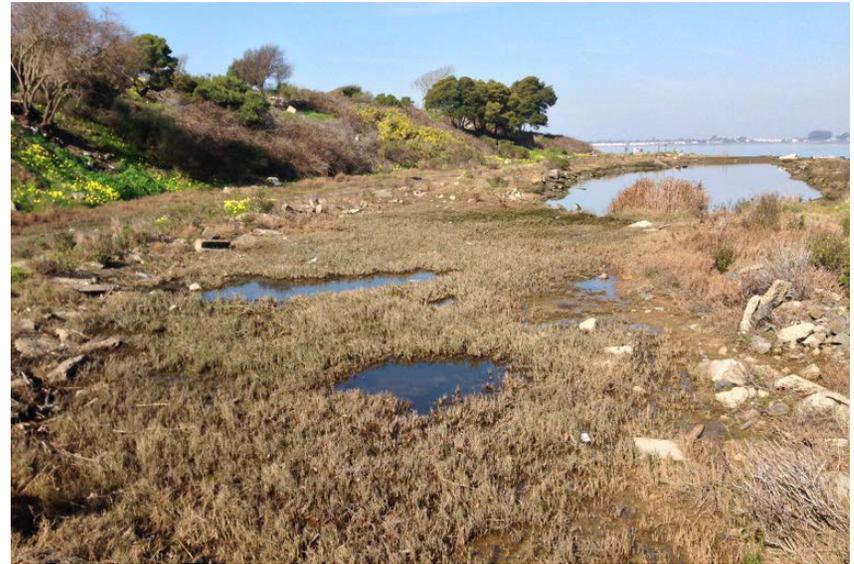
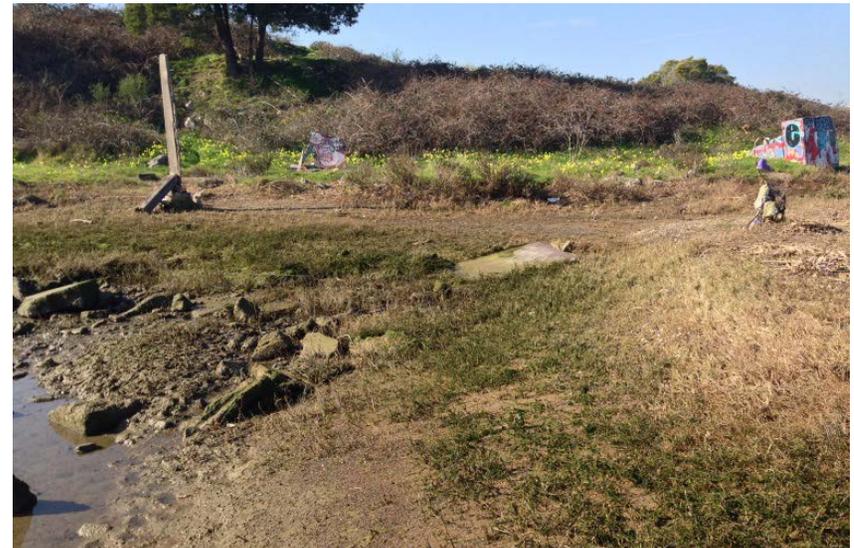
Photos 3.5 and 3.6. Small patches of muted tidal salt marsh at the southern (top) and northern (bottom) ends of East Lagoon. Photos: C. Toms (ESA).

Small patches comprising roughly a tenth of an acre of emergent muted tidal salt marsh habitat grow within the northern and southern ends of East Lagoon (Photos 3.5 and 3.6), on sediment that is likely a combination of fill soils and Bay Mud carried in on the tides. Like open water areas in East Lagoon, the marshes do not fully drain at low tide due to the sill effect of the lagoon's rubble berm. Both marshes lack subtidal channels, though the southern marsh supports two (2) small pond features. Due to the rubble and armoring that were used to construct the lagoon's perimeter berm, the landward edges of these marshes are truncated, and vegetation quickly converts from salt marsh to upland ruderal weeds along the higher portions of the berm. Landward of the perimeter berm is a heavily used path; a less-well-worn path also exists on the berm between the lagoon and the Albany Mudflats.

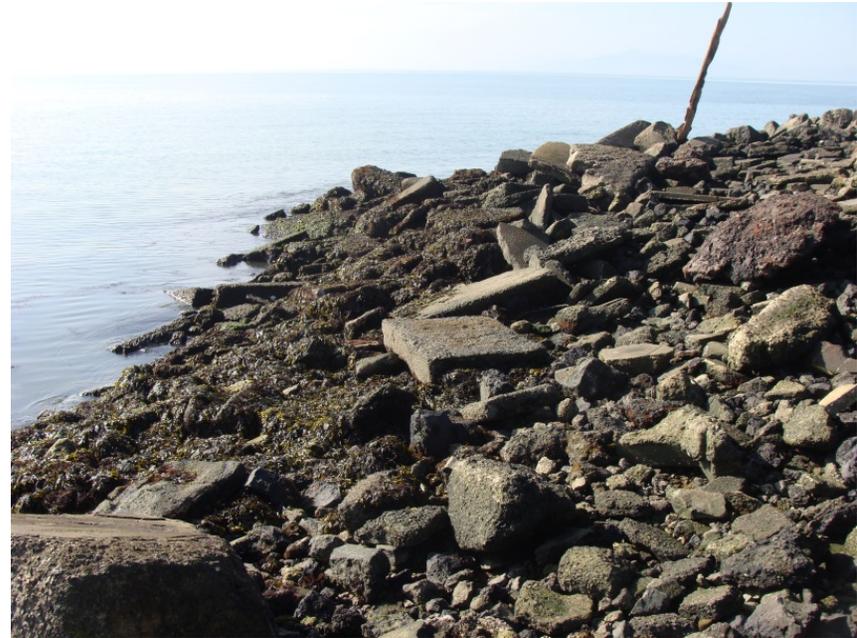
Photo 3.7. Armoring lines the entire Bulb perimeter. Photo: L. White (ESA).

The 6 ac of shoreline surrounding the Bulb (including the berms surrounding East and West Lagoons) are armored with concrete rip-rap and rubble (Photo 3.7). Small areas of the northwestern portion of the shoreline (in the sheltered corners of the unfinished landfill cell) support approximately 0.2 acres of coarse gravel and cobble pocket beaches formed by the weathering of rip-rap and landfill debris.
