Albany Neck & Bulb Transition Study

A Planning Tool for Site Enhancement

Existing Conditions Memo

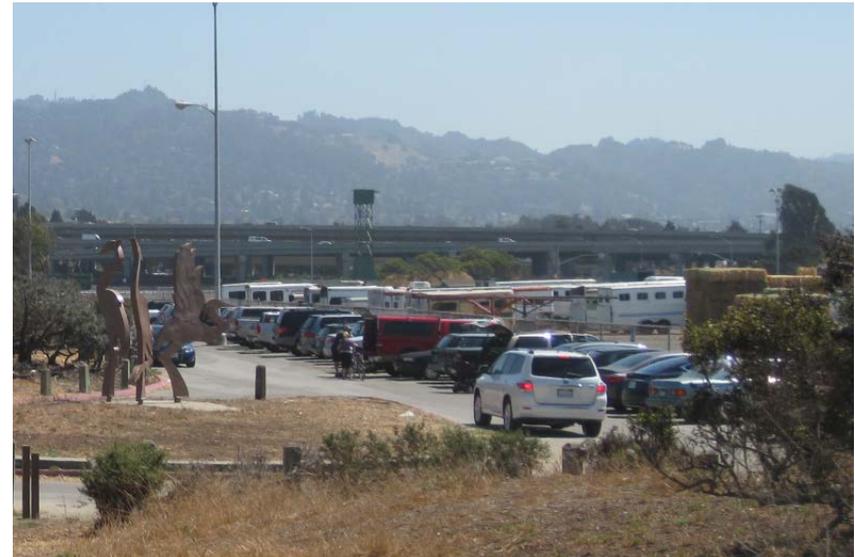
Photo 6.1. Buchanan Street Extension and the existing Beach and Neck/Bulb parking lot. Photo: S. Hammond (WRT)

Due to the study area's relative isolation west of I-80 and the Amtrak tracks and north of Golden Gate Fields, the only publicly available automobile access is via Buchanan Street Extension. The street is four lanes with no street parking between the I-80 underpass and the Golden Gate Fields parking lot entrance; west of the lot entrance, the street transitions to a two lane road with head-in, perpendicular parking along the south side and a small turn-around loop at the west end. Parking in the approximately 42 parking spaces (including two handicap spaces) is limited to two hours and is located on Golden Gate Fields property. Paving conditions along both Buchanan Street Extension and the parking area show signs of age, with cracking and potholes present. Current occupancy of the parking spaces appears to be high during most hours, with some illegal parking occurring during peak periods (e.g., during particularly nice weather). Turnover in spaces, however, also appears to be fairly regular, so few people have been observed turning away from the area due to lack of parking. Parking proposed as part of the beach improvement project

(see following discussion) will enhance parking capacity. In addition, the City has plans to remove the red curbs along the north side of the Buchanan Street Extension to create 42 on-street, parallel parking spaces, including 3 accessible stalls.

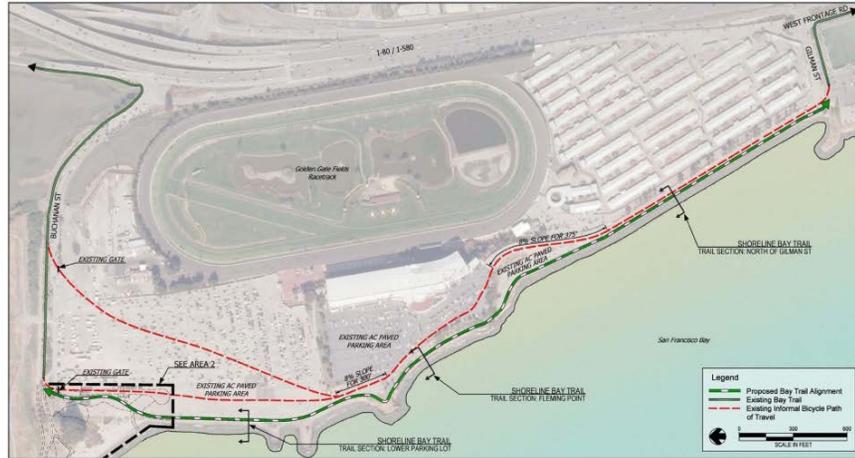
Figure 6.3: Albany Beach Project Site Improvements (SF Bay Trail Segment)

Source: Final Environmental Impact Report, Albany Beach Restoration and Public Access Project, November 15, 2012

The Albany Beach Project will provide numerous improvements related to biking and non-motorized transportation access. These include (see Figures 6.3, 6.4, and 6.5):

- Construction of a new 0.8 mile segment of the SF Bay Trail between the Buchanan Street Extension loop to the north and Gilman Street to the South.
- Installation of a low maintenance bicycle rack adjacent to the new Beach parking lot capable of holding at least 10 bikes, with expansion capability for up to up to 30 bikes.

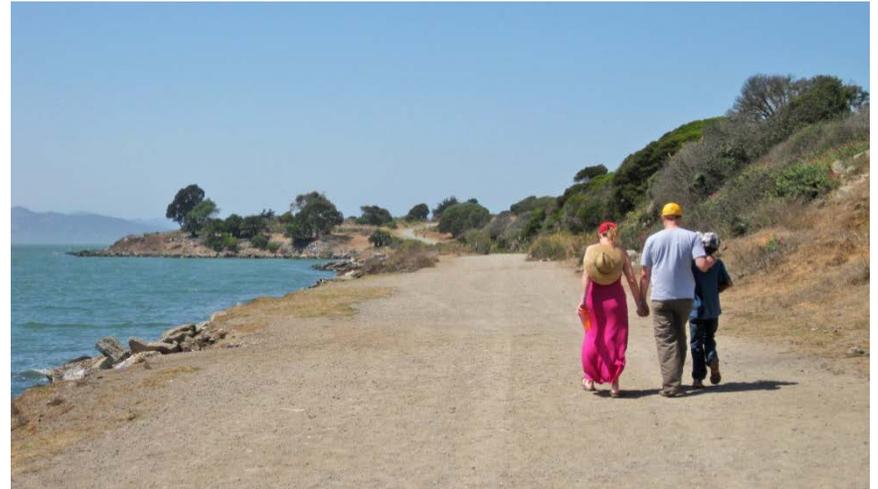
Photo 6.4. The lower trail on the Neck. Photo: J. Gibbs (WRT)

Repair of the existing trail surface on the lower Neck trail between the existing paved trail near the Buchanan Street Extension loop and the Bulb. Trail width will be narrowed from the existing 25- to 30-foot width to a minimum 14-foot width with 18-inch shoulders to avoid net Bay fill, maximize opportunities for additional shoreline habitat planting sites, and to manage site stormwater and drainage. The trail will be surfaced with a semi-permeable material and outslotted to provide diffuse drainage.

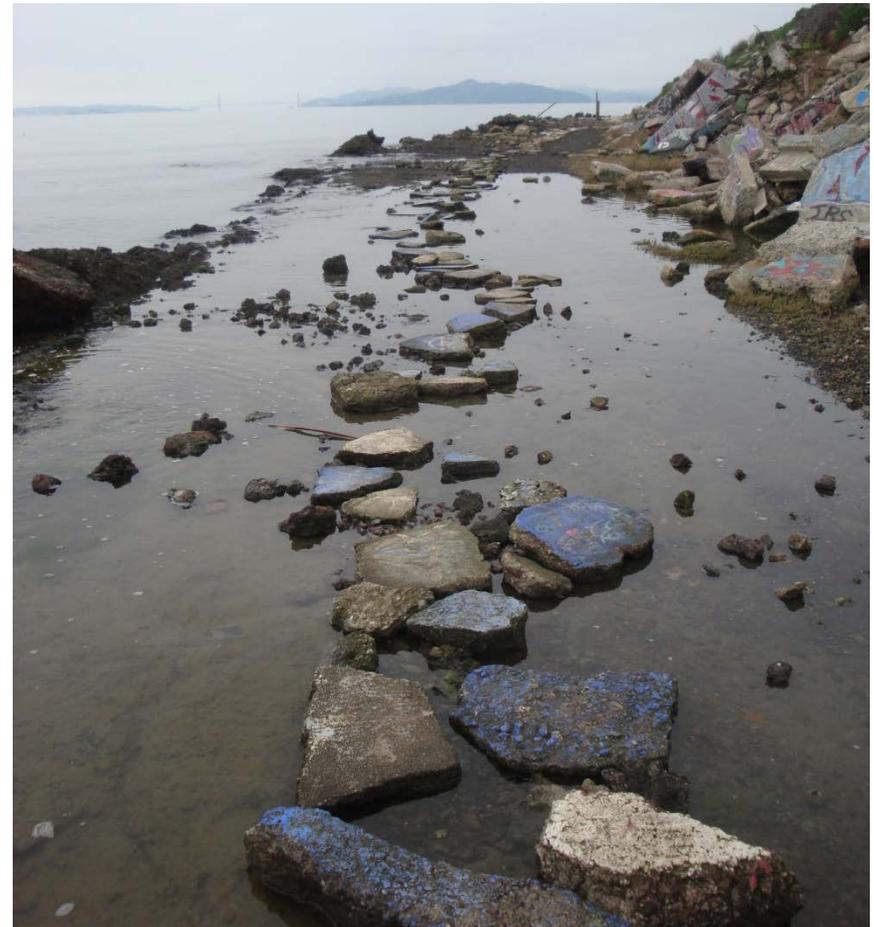
Anticipated sea level rise will have important implications for shoreline access. Higher water levels will cut off shoreline access for much longer periods in low-lying areas like the Yellow Brick Road trail along the Bulb's south shoreline and the beach along the northwest shoreline (see Chapter 2).

Photo 6.9. The Yellow Brick Road at mid-tide. Photo: J. Francis (WRT)

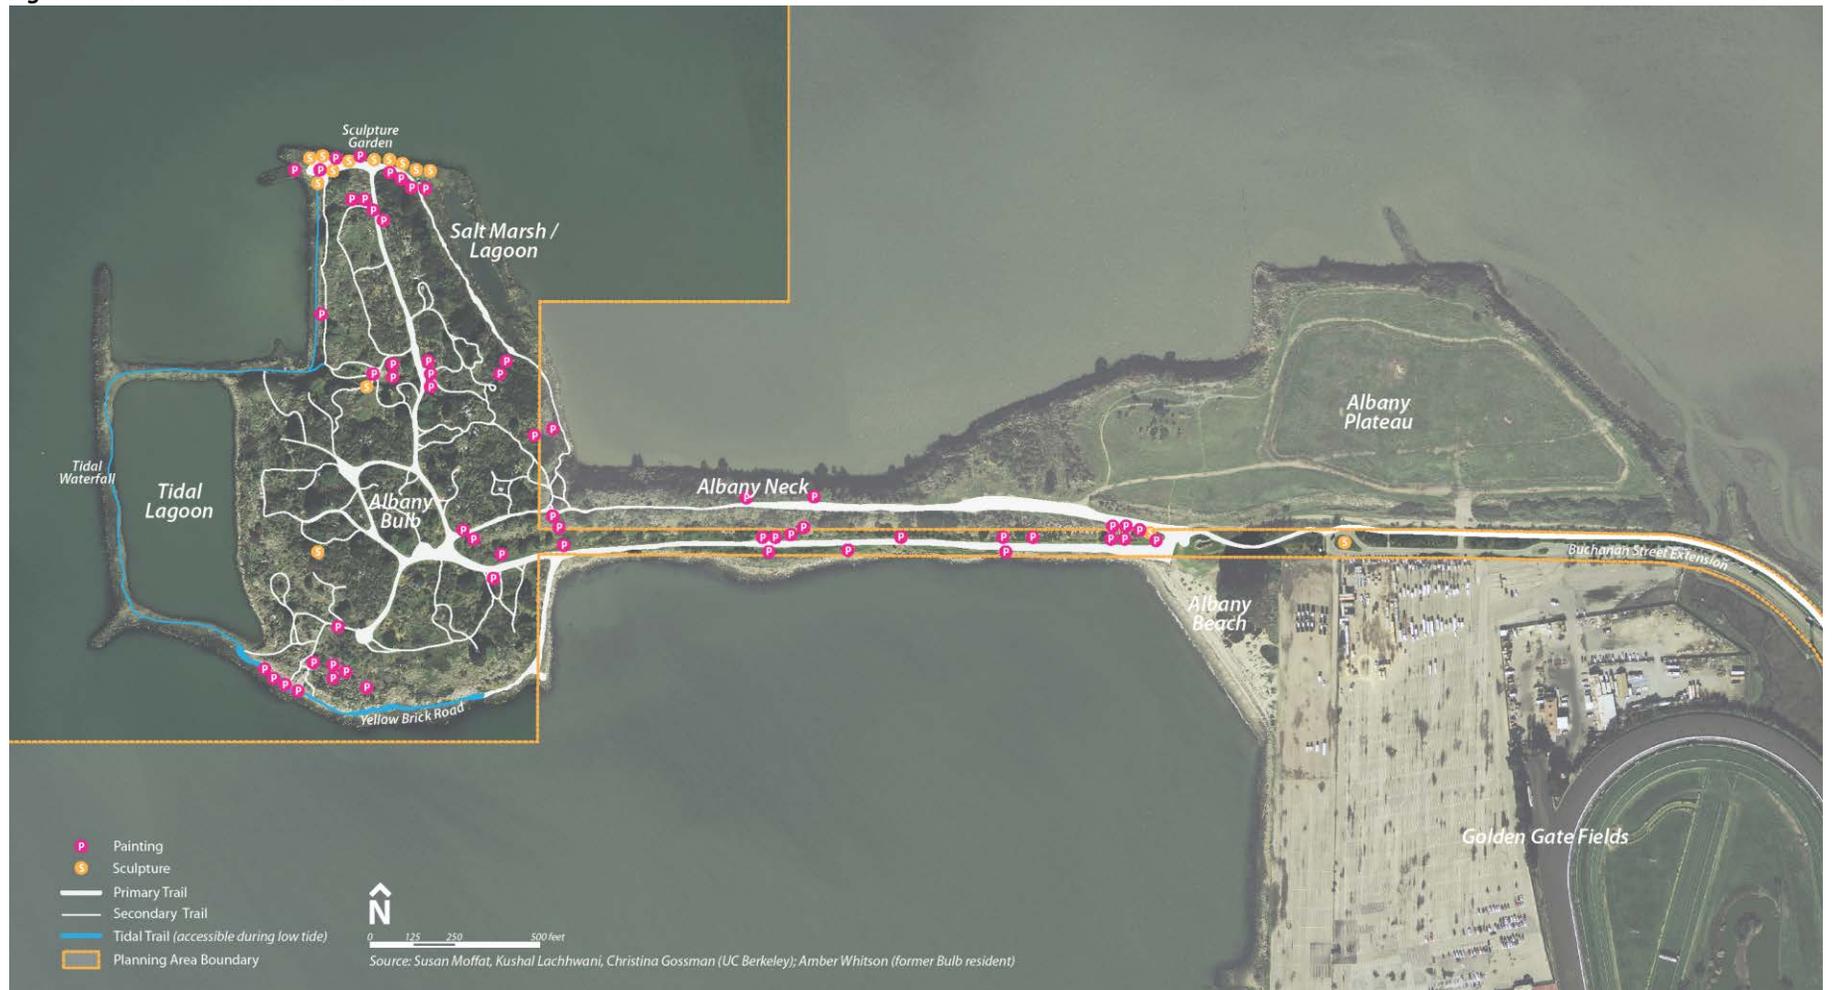
Figure 6.6: Art on the Neck & Bulb

For years, art has been an important feature of the Neck and Bulb. Most of the existing art works are either paintings on rocks and concrete fill material or sculptures made of found objects. Created by many artists over the years, some of whom occupied long-term encampments on the Bulb, the art is viewed by many as a part of the cultural landscape of the site that contributes to its unique sense of place. In many cases, the artists responsible for specific works are unknown. Over time, the integrity of many of the art works—particularly the sculptures—has deteriorated due to constant exposure to the elements and lack of maintenance. The locations of some of the most highly visible artistic works are noted in Figure 6.6.

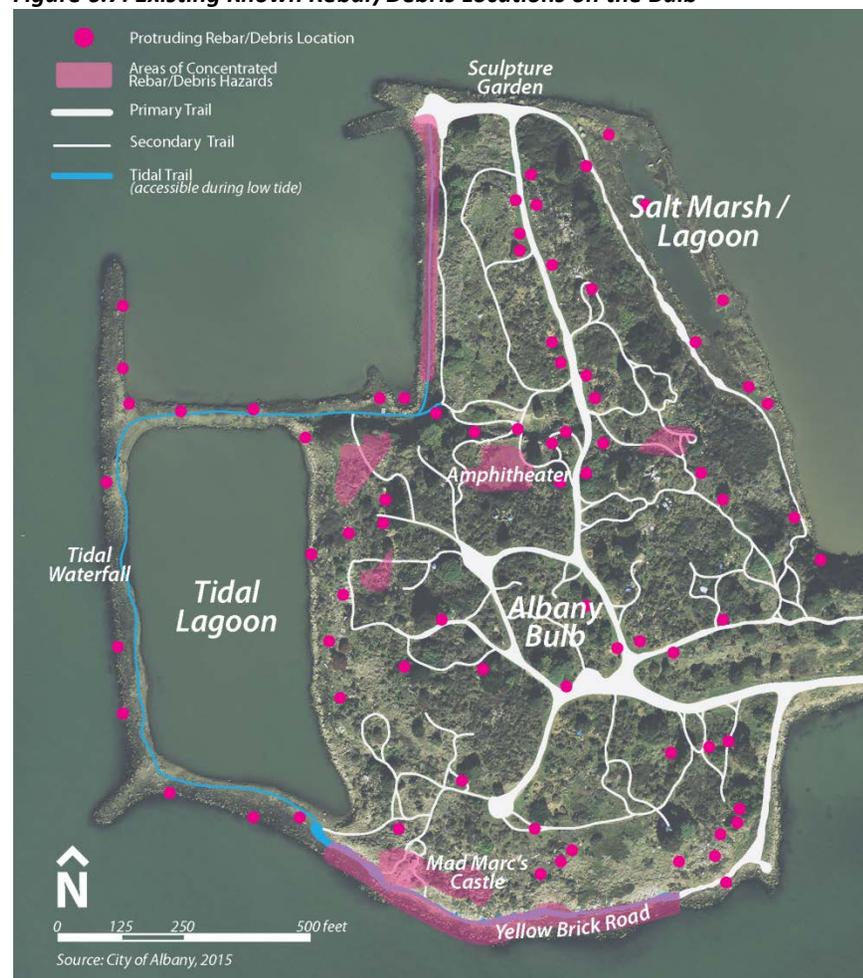
Figure 6.7: Existing Known Rebar/Debris Locations on the Bulb

Although not a consistent condition throughout, the Neck and Bulb include significant areas where exposed areas of concrete rubble and protruding rebar represent potential hazards to visitors. During the summer of 2015, the City of Albany undertook field work to identify existing known locations of protruding rebar on the Bulb, as shown in Figure 6.7. Due to the uneven surfaces and sharp edges of some landfill materials, these areas present high potential for tripping and injury, including anything from a twisted ankle to broken limbs, to lacerations and impaling on protruding rebar. That said, the majority of the Neck and Bulb area has either soil or vegetative cover that minimizes exposed hazards and the potential for such injury. Over time, however, as vegetation is trimmed back and/or soil erosion occurs, additional rebar locations that are currently covered by soil or vegetation may be exposed.

Stakeholders appear to prefer a targeted approach that focuses remediation of hazardous conditions along the most highly trafficked portions of the Neck and Bulb while leaving other areas as is. There appears to be a general feeling that protruding rebar represents the most significant threat to public safety, and that

remediation of areas with unsafe rebar would be appropriate. Remediation of hazards could be accompanied by a signage program warning visitors of hazardous conditions and a monitoring and maintenance program that identifies and removes newly discovered/uncovered rebar and other hazardous conditions.

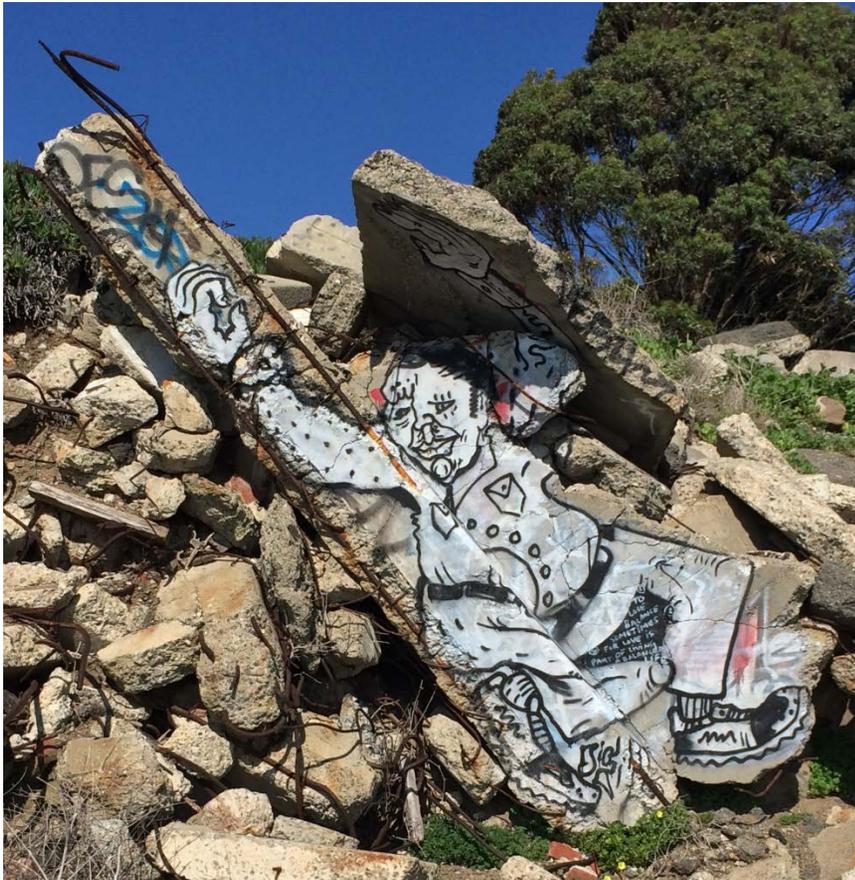
While the hazards represented by exposed landfill material remains an issue for some, the general consensus from stakeholders was that such materials were generally viewed as an important element contributing to the area's character and

Photo 6.18. Concrete rubble with exposed rebar. Photo: S. Hammond (WRT)
